FOSC Water Quality Blog – Maple Avenue Moles: Part 2

FOSC Storm Water Outfall Monitoring Team

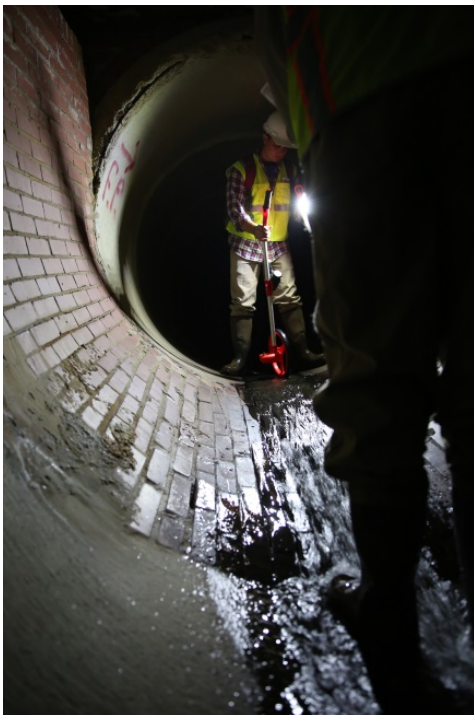
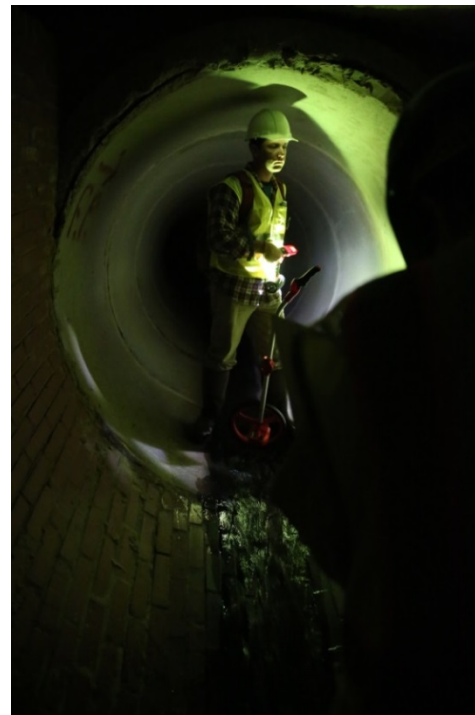
This is where storm water runoff collected from a number of streets along the Maple Avenue corridor to the south joins the main pipe we are traveling through. While the rest of the system is made of reinforced concrete pipe, most of these junctions are brick.

Torrella and Harless make note of the junction's distance, size and flow before we resume our journey into subterranean Takoma Park.

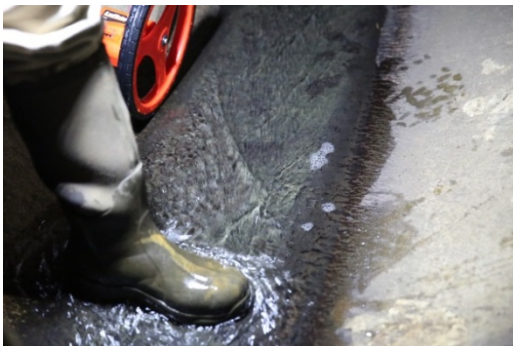
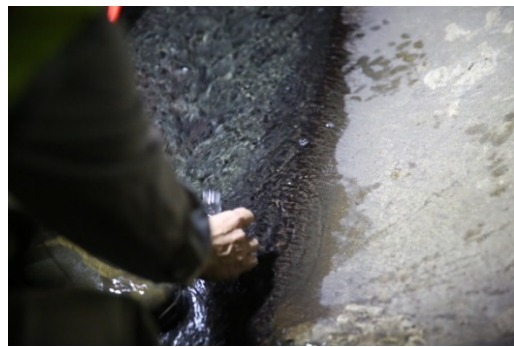
At this point in our journey, it's also proving difficult simply because the detergent isn't showing up. There's a modest, steady flow of cool water, but no bubbles. Then, somewhat perversely, our spirits rise when evidence of our elusive quarry appears. Fresh suds....

While there is not much volume, it is enough for Torrella to take a sample for analysis later back at the pipe outfall. These suds could be the harbinger of one of the huge detergent slugs we are expecting, but instead they die out rapidly, so we continue making our way up the pipe, heading toward a storm water collection vault about a half kilometer farther up the pipe. Along the way, we continue to pass the landmarks of this underground world. We see storm water inlets that likely deliver water from a single storm water drain or set of drains on a particular street....
