FOSC Water Quality Blog – Maple Avenue Moles: Part 2

FOSC Storm Water Outfall Monitoring Team

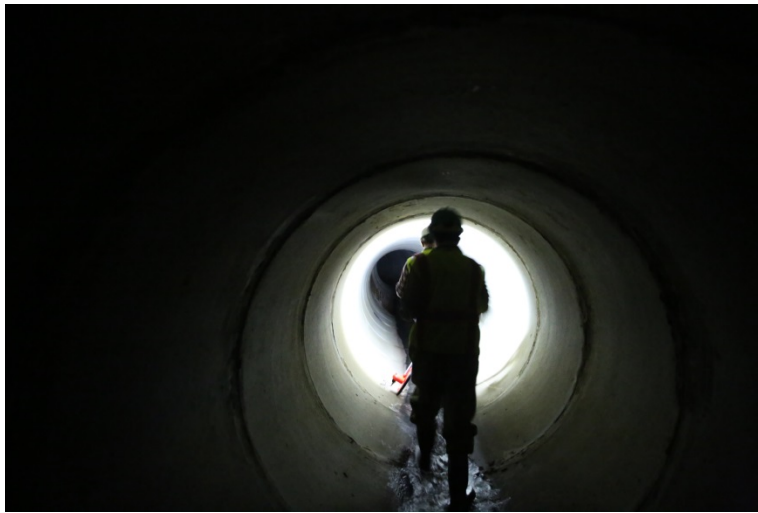
As part of the effort to track down recurring illicit detergent discharges into Sligo Creek, Montgomery County DEP Environmental Specialist Alex Torrella, Greg Harless of Stormwater Maintenance & Consulting and I recently slogged our way up into the Brashears Run storm water pipe system. Walking in a cylindrical pipe with a stream in it is more challenging than you might think. Below, the footing is slick and there are pipe seams to trip on. And above, there are hazards too. The pipe is 72 inches in diameter, so factoring in that your steps land part way up the side of the tube, as well as the height of the required hardhat, and it's likely you will bump your head on the jagged cement seams. Which is, I found out the hard way, a great reason to wear a hard hat.

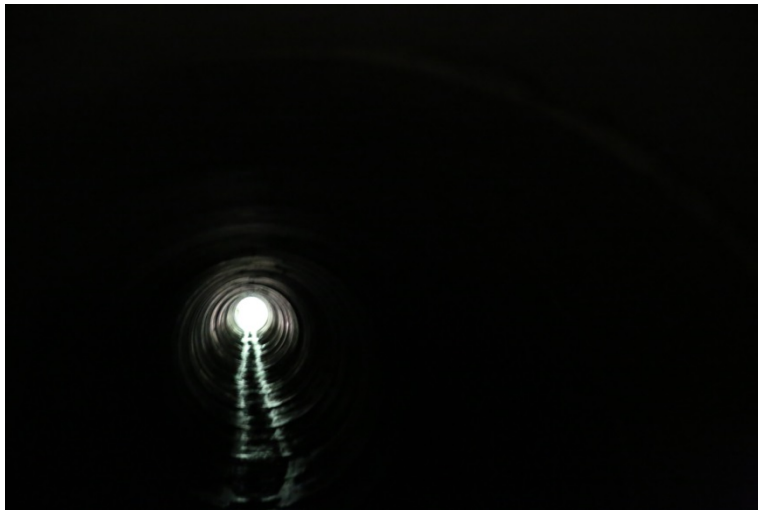
As we go deeper into the storm water system, I take a look back to see where we've come from. The grate, Maple Avenue and sunlight seem a long way away.

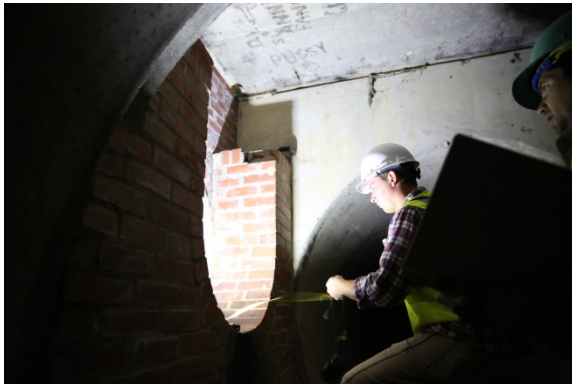
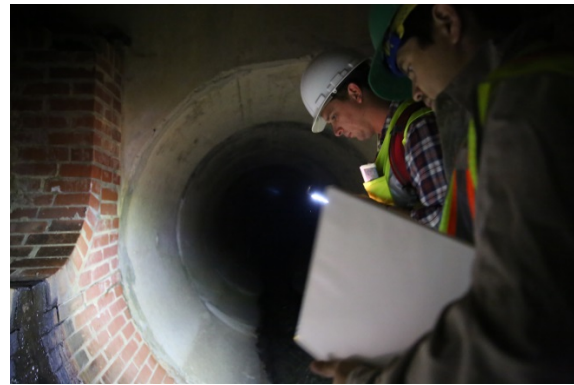
As we move forward, Harless keeps an eye on the portable meter that evaluates our air quality, all while keeping track of the distance we've traveled into the pipe. A few hundred meters in, we come across our first manhole access and storm water junction.

This is where storm water runoff collected from a number of streets along the Maple Avenue corridor to the south joins the main pipe we are traveling through. While the rest of the system is made of reinforced concrete pipe, most of these junctions are brick.

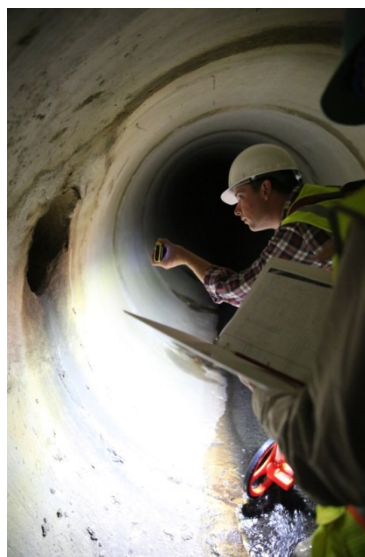
While there is not much volume, it is enough for Torrella to take a sample for analysis later back at the pipe outfall. These suds could be the harbinger of one of the huge detergent slugs we are expecting, but instead they die out rapidly, so we continue making our way up the pipe, heading toward a storm water collection vault about a half kilometer farther up the pipe. Along the way, we continue to pass the landmarks of this underground world. We see storm water inlets that likely deliver water from a single storm water drain or set of drains on a particular street....

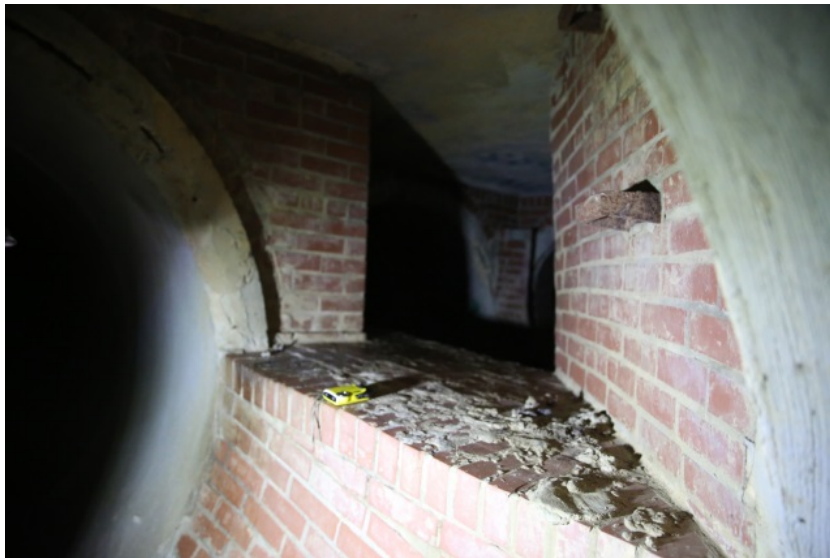
...and access cuts that allow workers (and excess storm flow) to travel between the larger 72-inch main pipes.

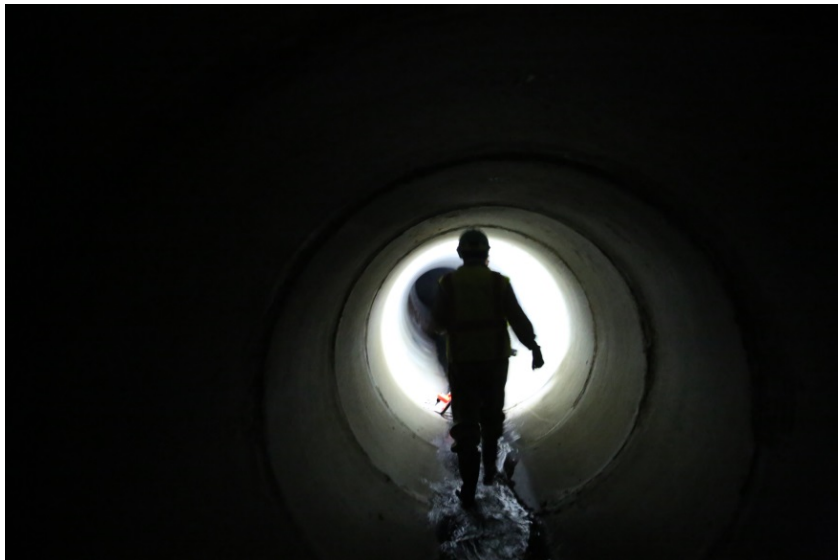
But mostly, it looks like this.

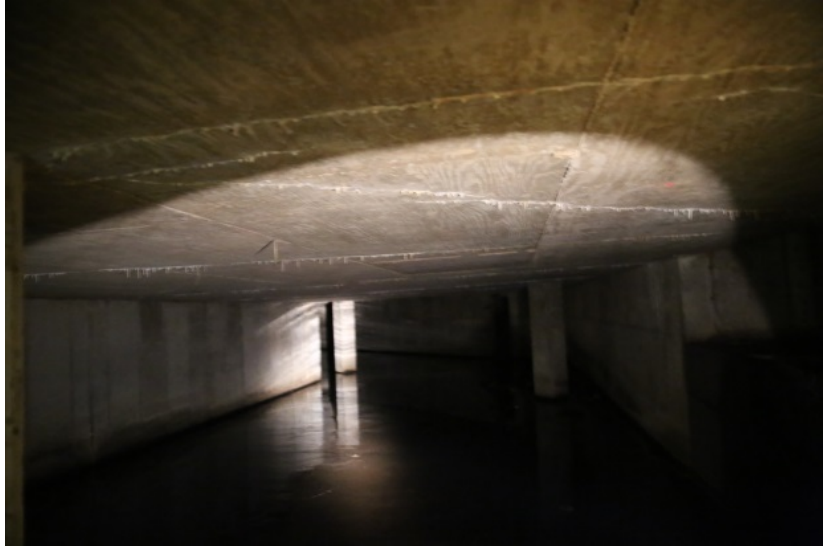
After another 10 minutes of hunched galumphing, the view finally changes. The cramped tunnel suddenly opens up into a concrete cavern that would not look out of place on the set of *Harry Potter and the Chamber of Secrets*.
